INDOOR AIR QUALITY ASSESSMENT

**Hopedale Middle/High School
Classroom 227
25 Adin Street
Hopedale, Massachusetts**

Prepared by:
Massachusetts Department of Public Health
Bureau of Environmental Health Assessment
September 2002

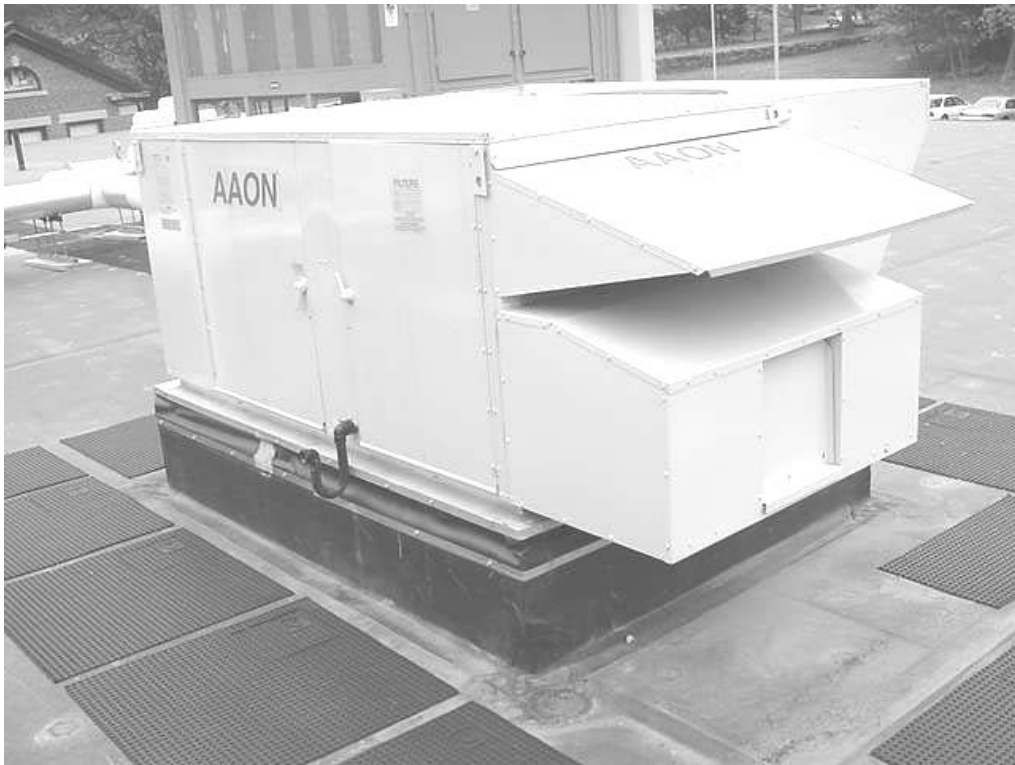
Picture 1

Fresh air is provided to the classrooms by a rooftop air-handling unit (AHU) and ducted to classrooms via ceiling-mounted air diffusers (see Pictures 1 & 2) located to the rear of the classroom. Mr. Rinehart reported that the HSD's HVAC contractor had recently adjusted the damper for the rooftop AHU to maximize outside air intake. Exhaust air is provided by return vents located at the front of each classroom which are identical to the supply diffusers shown in Picture 2. This system was functioning during the assessment.

Rooftop AHU Providing Ventilation to Classroom 227

To maximize air exchange, the BEHA recommends that both supply and exhaust ventilation operate continuously during periods of school occupancy. In order to have proper ventilation with a mechanical supply and exhaust system, the systems must be balanced to provide an adequate amount of fresh air to the interior of a room while removing stale air from the room. The date of the last balancing of these systems was not available at the time of the assessment. It is recommended that HVAC systems be re-balanced every five years (SMACNA, 1994).

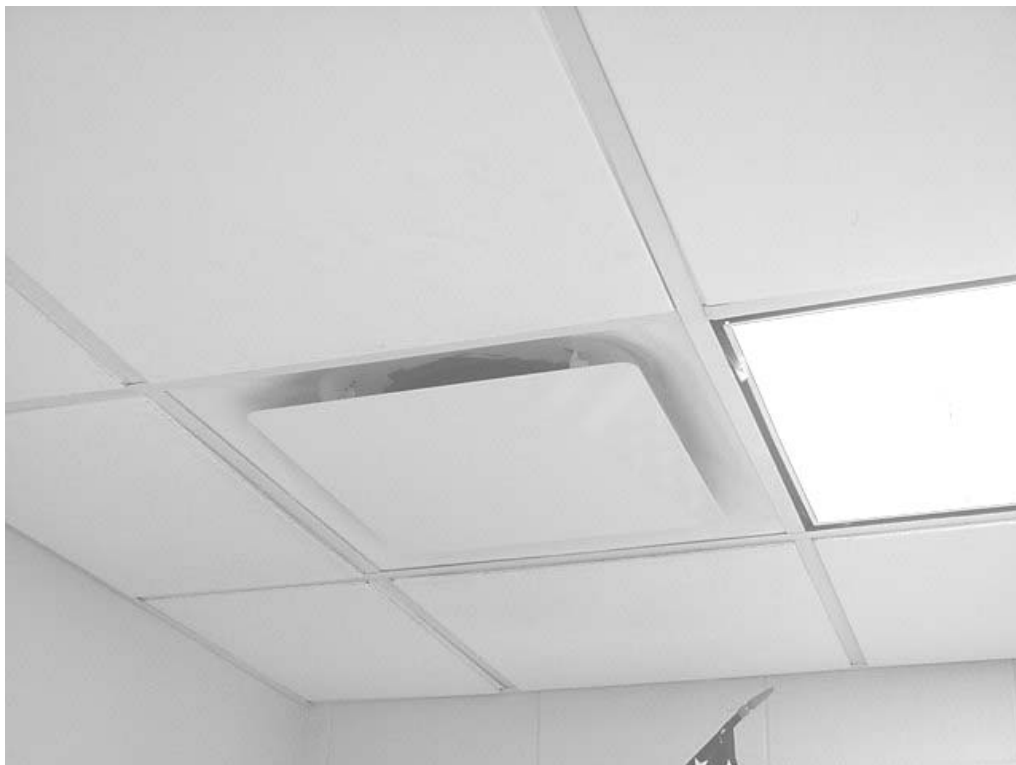
Picture 2

Supply Air Diffuser for Classroom 227

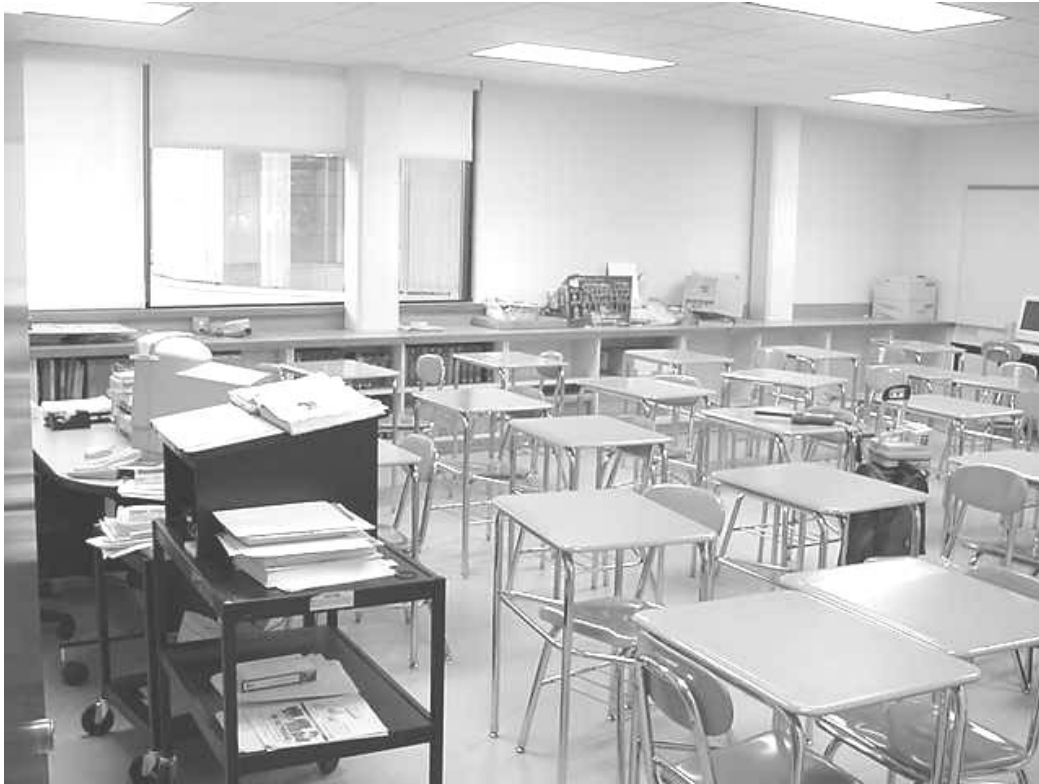
Picture 3

The main symptoms reported were eye and respiratory irritation. There are several inter-related issues that can contribute to this complaint. A likely cause of eye irritation is the accumulation of dust on flat surfaces. The room contained a number of flat surfaces upon which dust can accumulate (see Picture 3). A light coating of dust was observed on these flat surfaces with heavier accumulation to the rear of the classroom below supply air diffusers and on

Interior of Classroom 227, Note Room is Well-kept and Clutter is Minimal

2. Relocate or consider reducing the amount of materials stored in classrooms to allow for more thorough cleaning. Clean items regularly with a wet cloth or sponge to prevent excessive dust build-up.

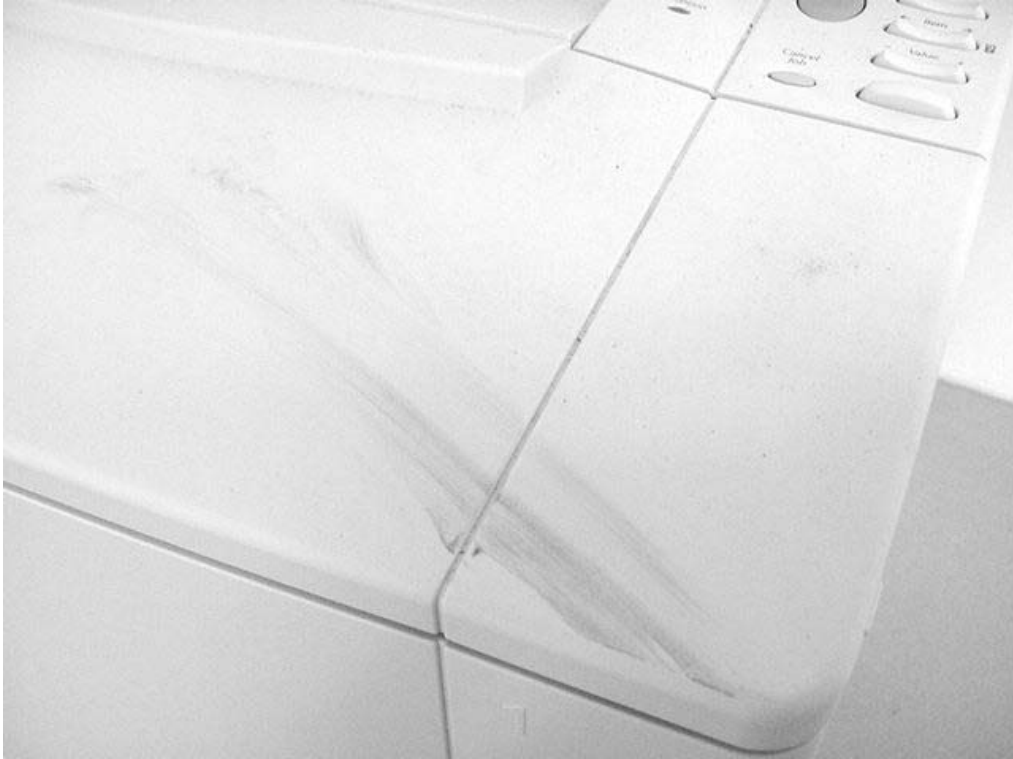
Picture 4

computer equipment (see Picture 4). Household dust can be irritating to eyes, nose and respiratory tract.

Accumulated Dust Smudged on Computer Equipment to the Rear of Classroom 227
